Alpha Electronics

Alpha Electronics Thermal Survey - Building

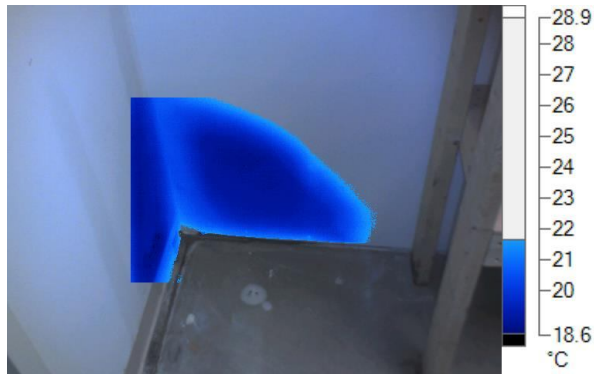
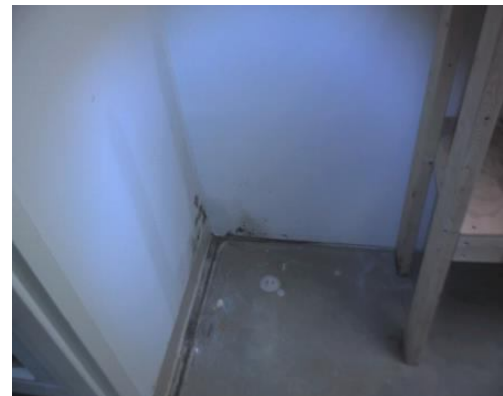
Wet Wall.is2

Inspection Date:	8/29/2006 12:29:34 PM	Area	Inside Basement
Location	Wall	Compass	
Description		Weather Conditions:	
Indoor Air Temperature		Outdoor Air Temperature	
Indoor Relative Humidity:		Outdoor Relative Humidity:	
Dew Point (inside):		Wind Speed	
Problem	Moisture	Repair Priority:	Medium
Emissivity:	0.90	Reflected Temperature:	21.1 °C
Camera Manufacturer	Fluke Thermography	Camera:	0607011

PROBLEM: Water has saturated the insulation & dry wall in a storage room adjacent to "concrete test sample misting room"

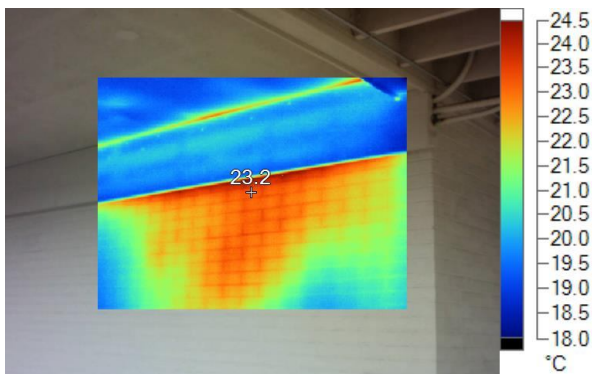
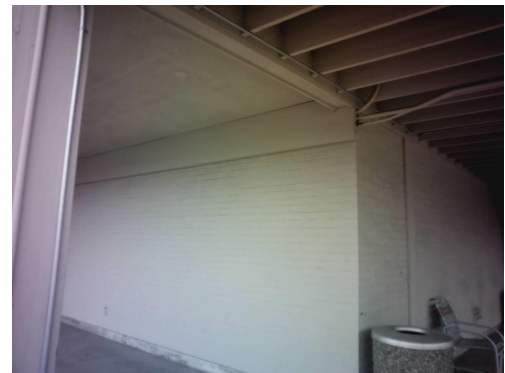
WallAnomaly.is2

Name	Temperature	Emissivity
Centerpoint	23.2°C	0.95
