Alpha Electronics

Alpha Electronics Thermal Survey - Building

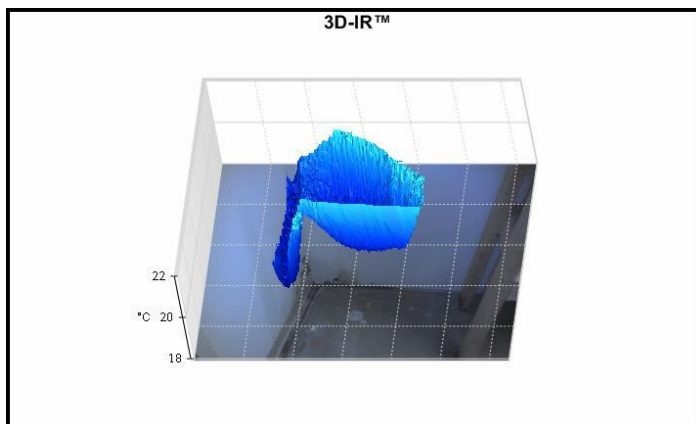
Graph

PROBLEM: Water has saturated the insulation & dry wall in a storage room adjacent to "concrete test sample misting room"
